Surgical Strike Paintball

Leak Diagnosis Aid

Angel A1

Michael Kramer – Certified A1 Tech

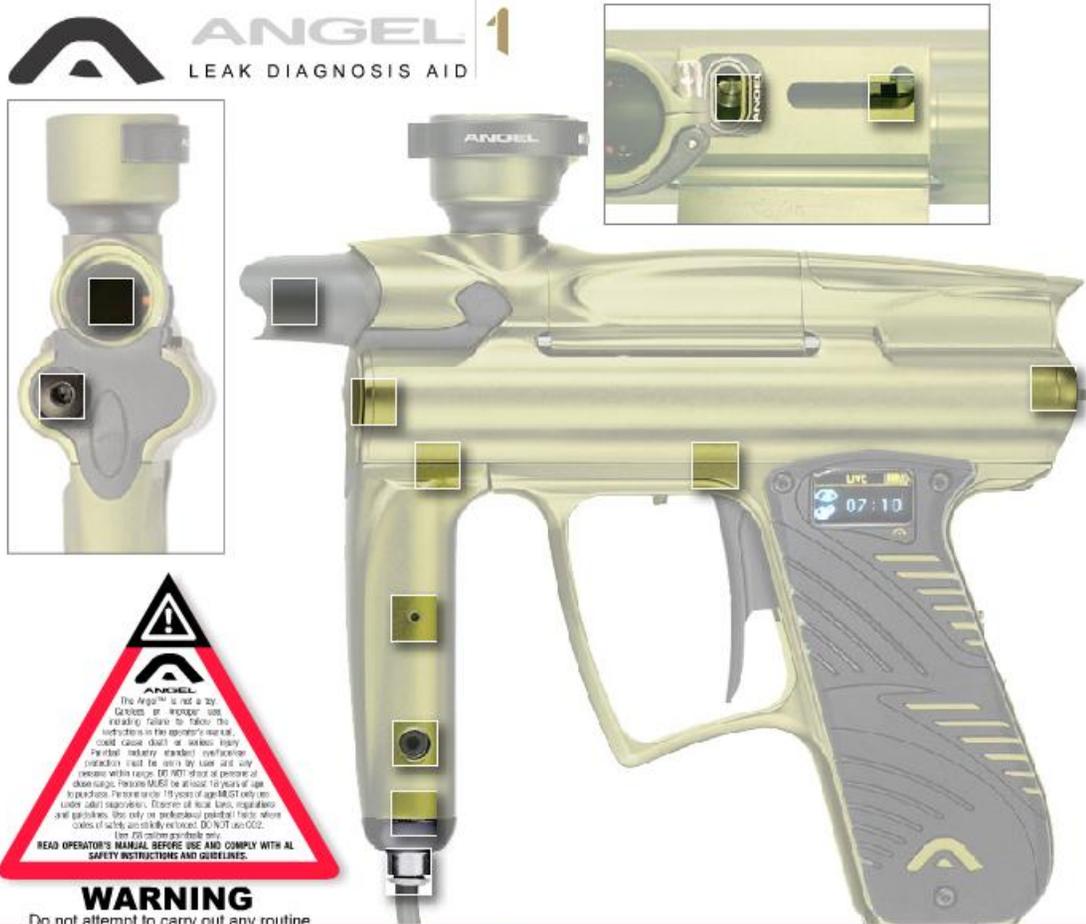
A leak from the connection between the high pressure hose and its fitting will be caused by wear to the hose, remove the hose from the fitting and trim it square with a sharp knife so that a new section of hose is in place. It may be required to replace the hose fully if its length is too short to trim and still be pushed fully and firmly into place.

A leak from between the high pressure gas fitting and the fore grip end cap will be caused by a failure in the lock tite used to secure the high pressure fitting in place. Remove the high pressure fitting from the end cap and re apply the appropriate strength loc tite high pressure sealant and allow to cure to seal the fitting back into place.

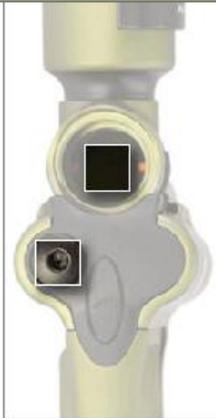
A leak from between the fore grip and the fore grip end cap will be caused by the end cap being loose, or the end cap 'O' ring being cut or damaged or out of its retention groove, replacing this 'O' ring and ensuring it is correctly located within its location groove will correct this.

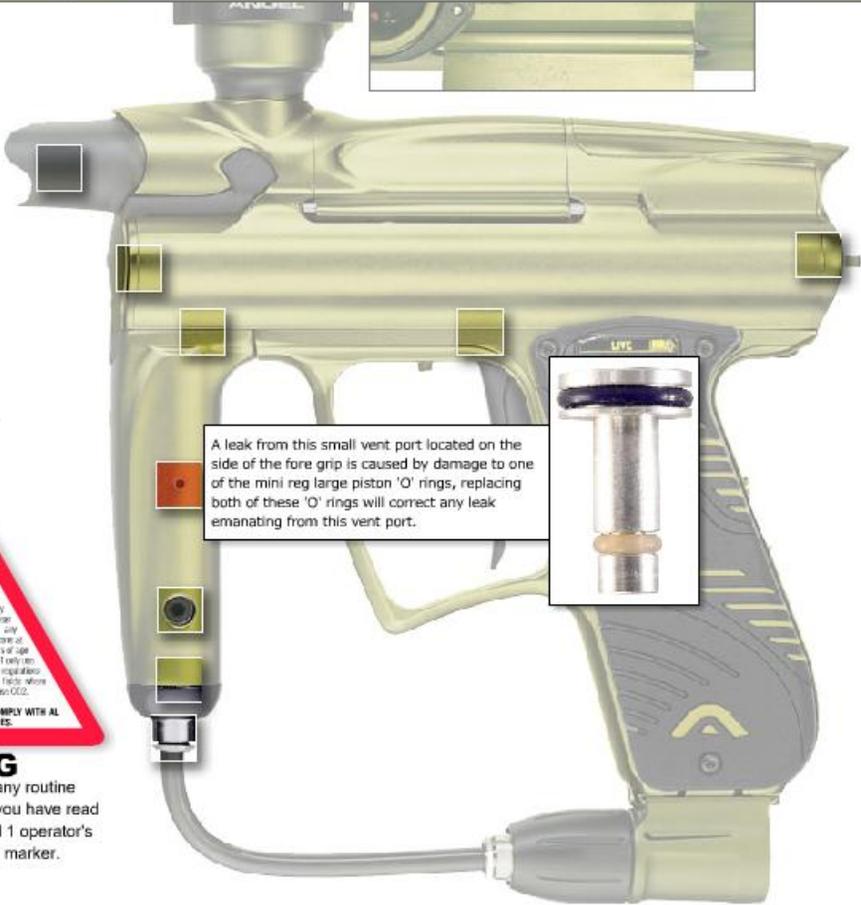
A leak from this small vent port located on the side of the fore grip is caused by damage to one of the mini reg large piston 'O' rings, replacing both of these 'O' rings will correct any leak emanating from this vent port.

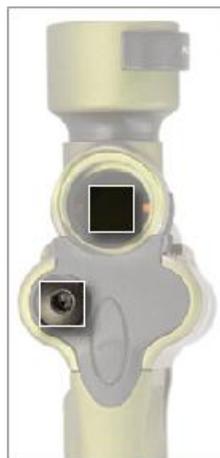
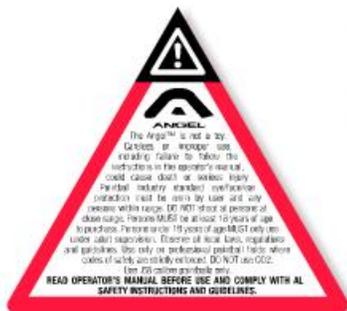
A leak from between the body and the grip frame can be caused by a cut or damaged seal on the LPR body or on the LPR piston, replacing these 'O' rings will correct this.

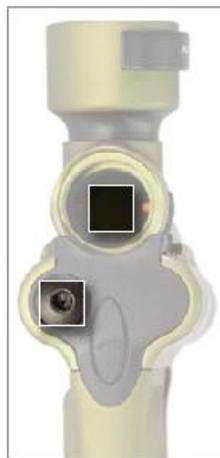
A leak from the back of the Angel can be caused by a cut or nick to the rearmost ram body 'O' ring **3**, replacing this 'O' ring will correct this.

A leak from the back of the Angel can be caused by a cut or damaged solenoid gasket **4**, a solenoid not clamped down enough, or damage to one of the internal seals inside the solenoid. This can be corrected by changing the gasket **4** that sits between the solenoid and the body, checking to see if the solenoid is clamped down fully, or replacing the solenoid.

A leak from the back may be caused by an over pressurizing LPR this can be caused by damage to the internal face seal **5**. Replacing this portion of the LPR will return the pressure back to its normal range and will correct this leak.

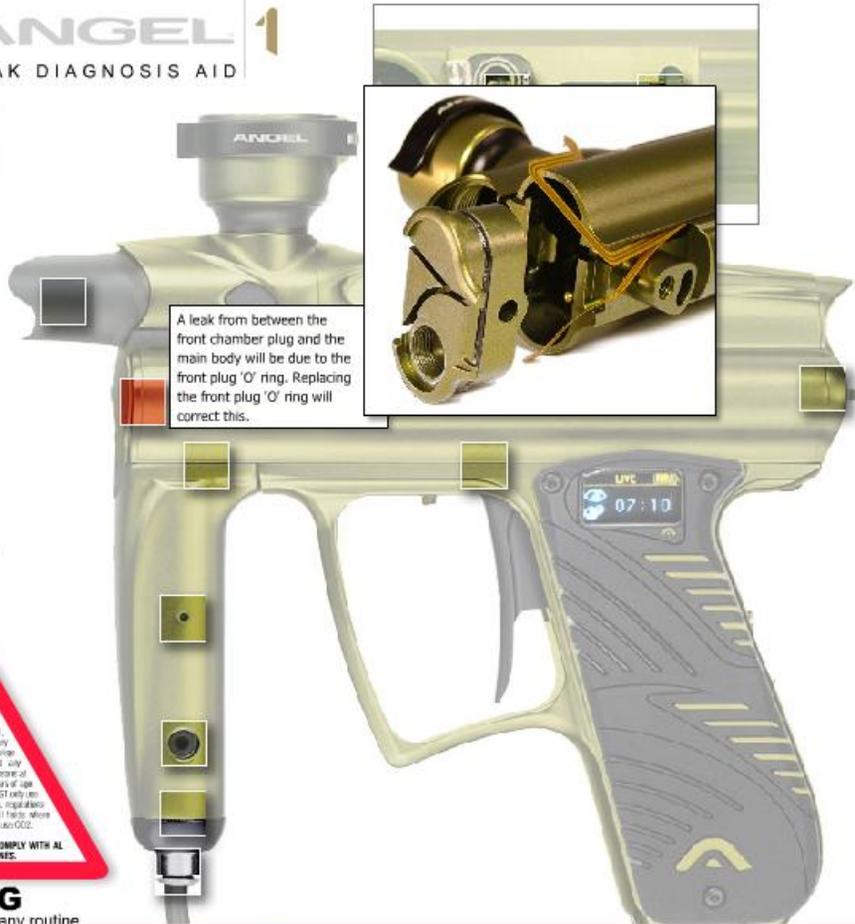
A leak from between the front chamber plug and the main body will be due to the front plug 'O' ring. Replacing the front plug 'O' ring will correct this.

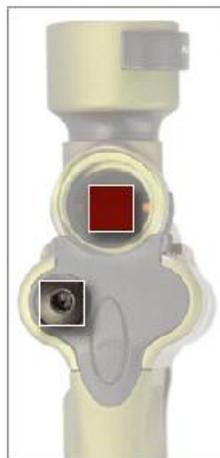
If a leak from the barrel is experienced it will be due to a leak from the **exhaust valve stem/guide assembly** or the **ram** (see inset above). The breech will need to be opened and further investigation will be required to determine the source of the leak.

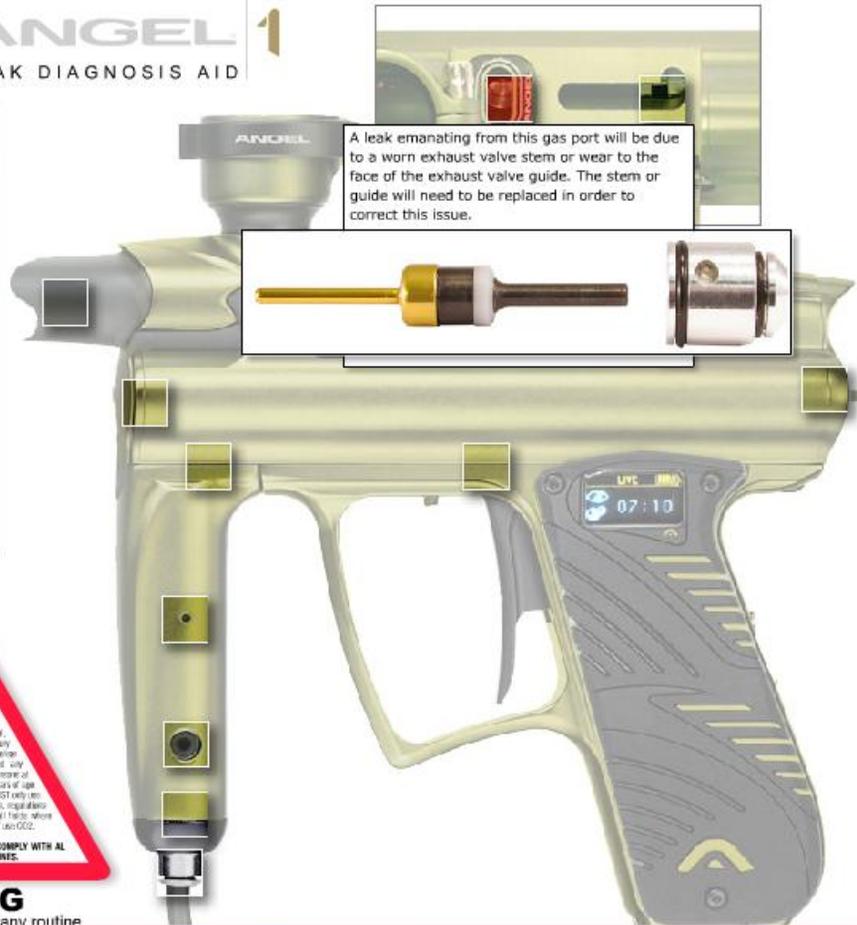
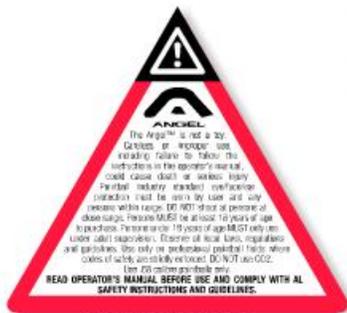
A leak emanating from the ram will be due to a nick or cut in any of the following seals, the front ram body 'O' ring **1**, ram rod shaft 'O' ring **2**, or the ram's internal piston 'O' ring. The front ram body 'O' ring and ram rod shaft 'O' ring can easily be replaced however the ram's internal piston 'O' (not shown) ring can not be accessed to get replaced so if this was the cause of the leak the ram will need to be replaced.

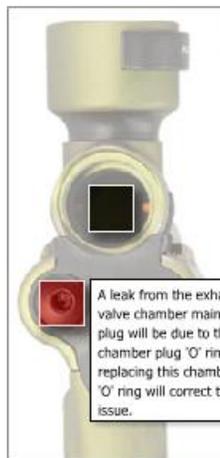
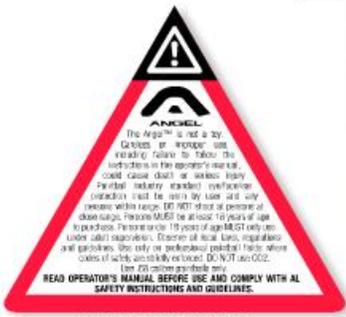
A leak from the exhaust valve chamber maintenance plug will be due to the chamber plug 'O' ring, replacing this chamber plug 'O' ring will correct this issue.
