**SHOCKER XLS**  
BODY CHANNEL LEAK GUIDE

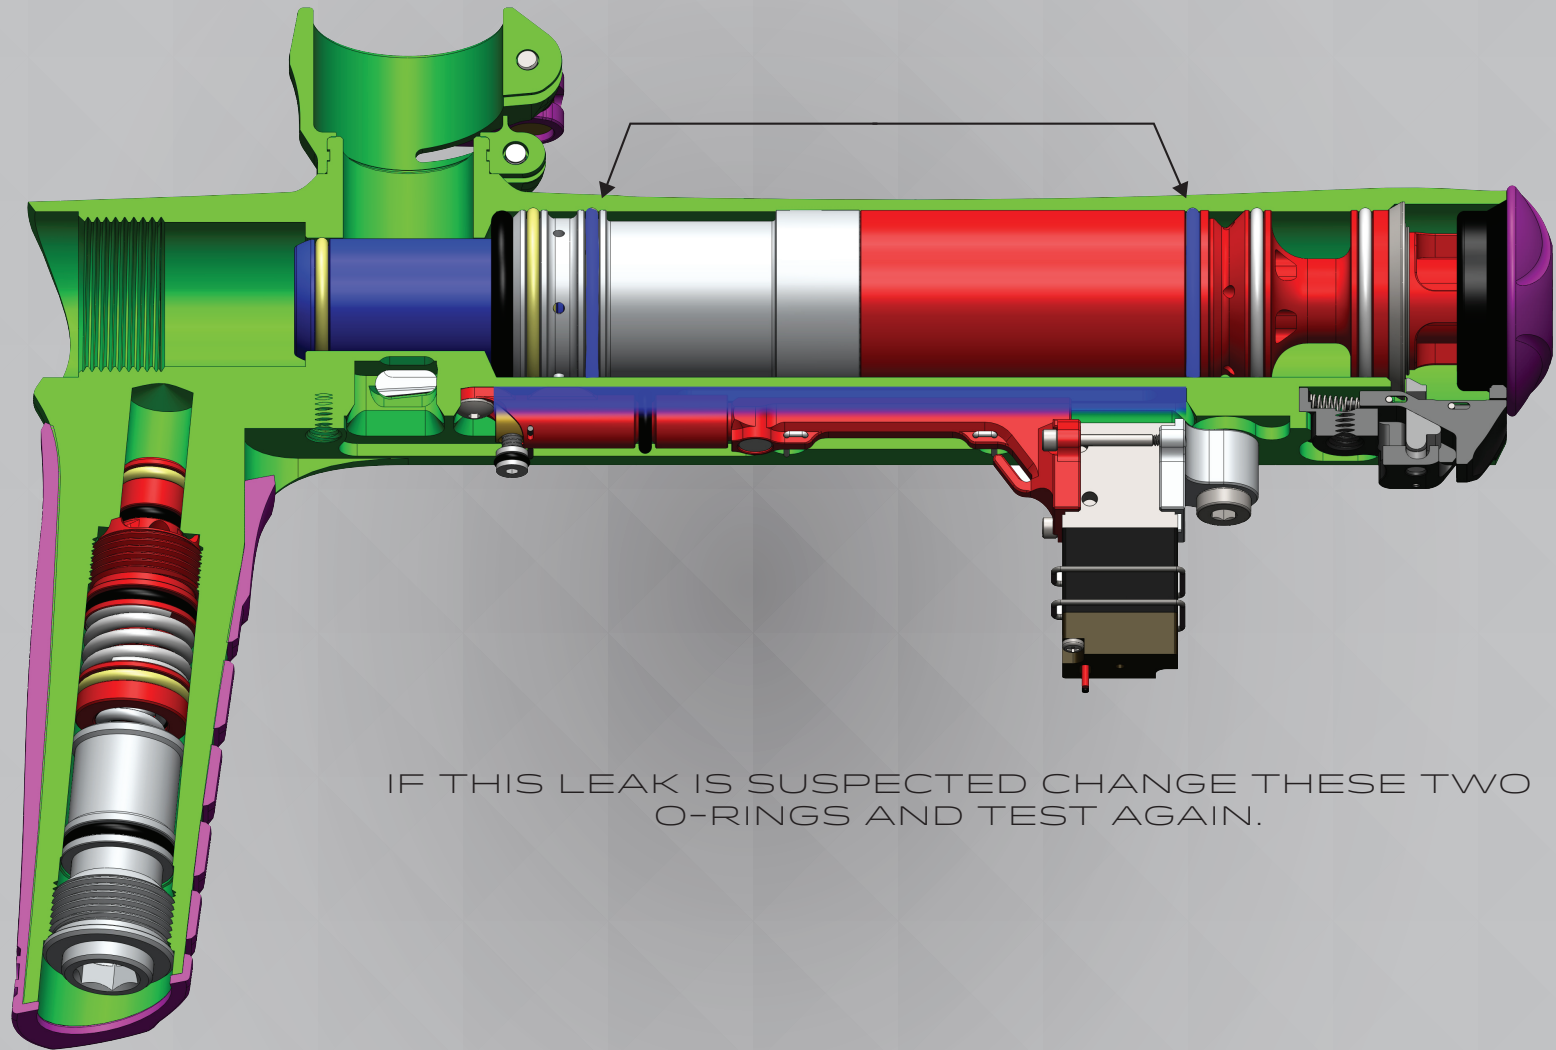
IF THIS LEAK IS SUSPECTED CHANGE THESE TWO O-RINGS AND TEST AGAIN.
