IN ORDER OF LIKELYHOOD

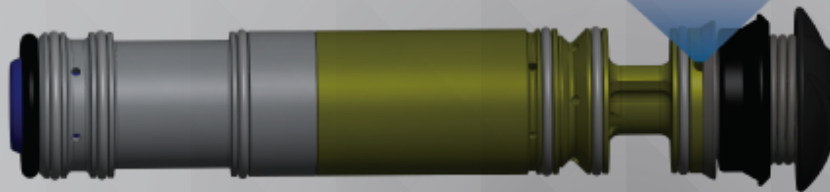
O-RING - 0M3020
-

O-RING - 0B7M14
-

O-RING - 0B7D18
-

SET SCREW - RE-LOCTITE

**Tech Tip:** To confirm the leak is coming from the pictured vent hole, plug the hole with a small amount of grease then air up the marker - if the grease is blown out, then you have confirmed the leak location.
